THE EFFECT OF ANTHROPOGENIC ACTIONS ON THE WEATHERING OF POROUS BUILDING STONES – EXAMPLES FROM THE AUSTRIAN CONSERVATION PRACTICE*

Farkas PINTÉR¹

¹ Scientific Laboratory, Federal Monuments Authority Austria, Arsenal 15/4, A-1030 Vienna, Austria

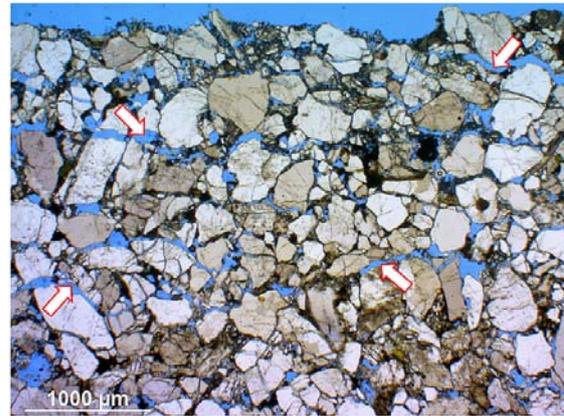
Fig. 2.: Characteristic textural appearance of flysch sandstone (subarkose) from Lower Austria (sample TU, 1N). Arrows show microcracks formed due to weathering processes.

Macroscopic appearance of the stone ashlar of the Romanesque ossuary in Tulln, Lower Austria, one of the most significant objects made from the Wienerwald Sandstone, showed granular disintegration and back weathering (Fig. 5.). Although this sandstone type (Table 1.) is characterized by high porosity and a more variable mineralogical composition, the microscopic degradation pattern is very similar to that of the sample KR and is characterized by cracks running sub-parallel to the outer surface (Fig 2.).

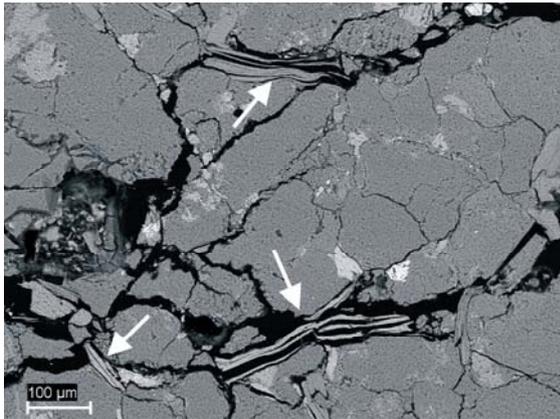
While the existence of damaging salts in the cracks could be excluded as a reason for the damage (Pintér 2018), sheet silicates (i.e. muscovite mica) exhibiting flaking lamellae were frequently observed in or in the vicinity of microcracks (Fig. 4.).

Fig. 4.: Formation of microcracks in the vicinity of mica lamellae (arrows) due to freeze-thaw damage (sample KR, SEM-BSD).

Consequently, the observed degradation pattern was clearly ascribed to physical processes, where no salt crystallization took place. Fine-grained flysch sandstones frequently show high affinity for hygric dilatation, a result of a certain amount of swelling clay minerals (Rohatsch 2003, Ban 2014), but in the present sample only mica was observed, thus the role of swelling clay minerals could also be excluded.

Based on the combined investigation of damaged samples and a local inspection at the object, it can be stated that the reason for the damage was a consequence of incorrect water draining on the façade and subsequent freeze-thaw cycles. The role of infiltrating water was also suggested by a thin calcium carbonate precipitation layer on the surface of the investigated stone slab. $\text{Ca}(\text{OH})_2$ leached from cement-based joint mortars in the vicinity of the investigated slab and precipitated and carbonated on the stone's surface also suggests the intensive impact of moisture on the façade where the damage was observed. Finally, intergranular microcracks indicate the relatively weak bounds between the sandstone grains, where mica grains acted as additional weak zones in the stone texture in two different ways. First, the weak bounds between the mica lamellae may favour the formation of cracks due to higher capillary suction compared to their vicinity and, secondly, highly acute mica wedges can be effective nucleation sites for ice crystallization (Campbell et al. 2017). Therefore, microporosity conducted the moisture from the surface into the stone's interior, where, predominantly in the vicinity of mica crystals, due to freeze-thaw attack crystallization pressure provoked the formation of microcracks and thus the loosening of the stone's structure.

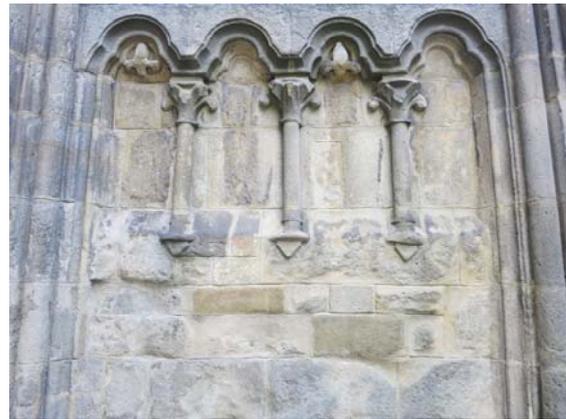
Fig. 5.: Characteristic weathering pattern, granular surface disintegration and back weathering of the Wienerwald (flysch) Sandstone on the north façade of the Ossuary in Tulln, Lower Austria (picture courtesy J. Nimmrichter).

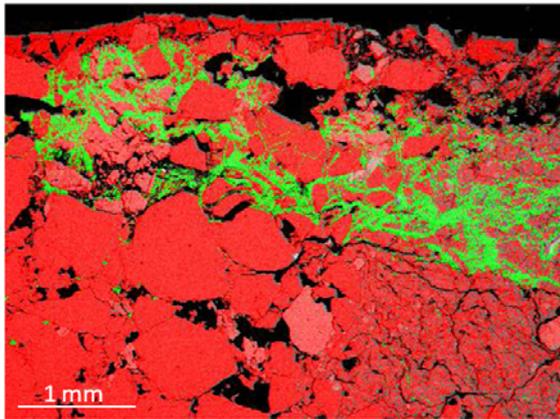
Although the pores and cracks are partly filled with gypsum up to a depth of 1.5 to 2.0 mm (Figs. 6 and 7.), a characteristic salt crust could not be detected on the surface. Careful investigation of the sample revealed that the pores and cracks in the sub-surface zones contain silica gel, indicating a stone consolidation treatment using an ethyl silicate consolidant (Fig. 8.). The first application of ethyl silicate at the object - and simultaneously in Austria - was performed during the 1970s (Nimmrichter 2007). Since then the consolidation has been repeated on different parts of the object in five different conservation campaigns (Ban 2014). In the analyzed sample at least two generations of silica gel with different water content could be observed, due to their different grey values in the backscattered electron images.

Fig. 6.: Cracked subsurface zone (red: Si = quartz, feldspar, etc.) filled with gypsum (S: green) in the sandstone sample TU. SEM element mapping

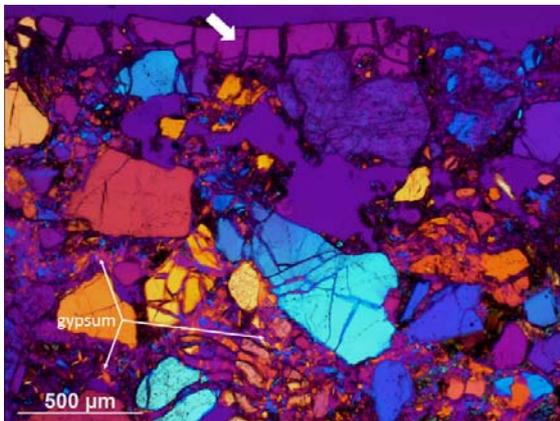
Fig. 7.: Cracked subsurface zone covered with a thick layer of silica gel (thick arrow) on the surface indicating a former consolidation. Partly cracked grains are filled with gypsum (sample TU, +N, λ plate)

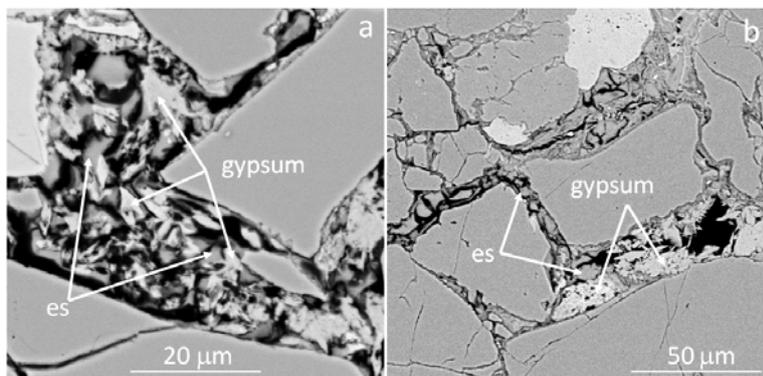
Fig. 8.: Silica gel (es = ethyl silicate) situating between gypsum crystals (a) and calcium sulphate growing on the surface of the silica gel precipitations (b) indicating the formation of gypsum before and after consolidation, respectively (sample TU, SEM-BSD image)

The spatial distribution of gypsum and silica gel showed that in some areas gypsum crystals are covered by the silica gel (**Fig. 8a**) and in other, mostly deeper zones hypidiomorphic calcium sulphate grew on the surface of the consolidant (**Fig. 8b**).

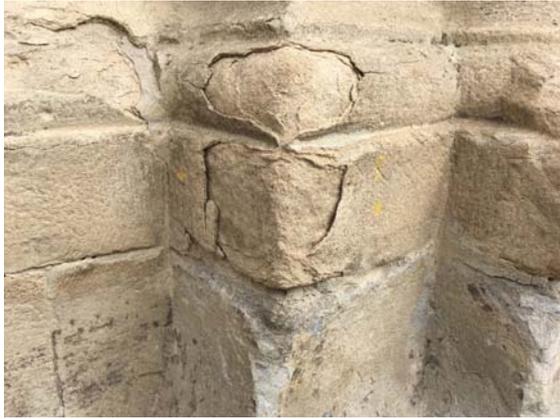
Fig. 9.: Flaking of molasse sandstone due to thermal/hygric dilatation and/or freeze-thaw cycles on the footing of the Parish church in Schöngrabern, Lower Austria (image courtesy J. Nimmrichter)

Another typical sandstone degradation phenomenon was observed in the Romanesque parish church in Schöngrabern, Lower Austria. Flaking of stone ashlars, especially on exposed edges (Fig. 9.) up to a depth of 1.0 cm, indicated prolonged weathering processes. Salt analyses based on ion chromatography, IC (Pintér 2019a) indicated the presence of calcium and magnesium sulphate salts. Detailed microscopic analyses confirmed that in the damaged sample a crack system sub-parallel to the outer surface existed. SEM-EDS also proved the presence of sulphates up to a depth of approx. 2.5 mm, where only gypsum was detected. Although microcracks and joints are completely filled with calcium sulphate, the dolomite cement seemed to be completely intact (Fig. 10.), suggesting that the sulphate salts were not directly formed by the reaction of $\text{CaMg}(\text{CO}_3)_2$ and SO_4 ions, otherwise magnesium sulphate would also have crystallized in the cracks. Thus, magnesium measured in the sample by IC originated from the sparitic dolomite binder of the stone leached out from the bulk sample during the elution in the laboratory.

The formation of cracks seems not to be connected directly with the crystallization of gypsum, which is also suggested by joints free of any secondary salts. The most probable explanation for the primary damages was thermal- and/or hygric dilatation induced stresses and subsequent loss of cohesion and not the formation of calcium sulphate. This theory is also supported by previous observations and research on the conservation history of the object (Nimmrichter 2007). Thus, the first damages have already been observed in the 19th century, when lime-based renders and coatings, the so-called protective sacrificial layers, were completely removed from the walls. Consequently, the yellowish-brown sandstone surface, especially on the east and south façades, could absorb more heat that provoked an increased thermal dilatation. Furthermore, the removal of the lime coating that acted as a buffer zone, created a direct contact between the stone surface and its surroundings, allowing a higher moisture uptake through capillary suction. Additionally, the crystallization of crack-filling gypsum caused a denser outer layer of several millimetres thickness (Fig. 9.). The lower porosity and stiffness of this crust increased the effect of thermal and hygric dilatation as well as freeze-thaw cycles and thus a more intense degradation of the stone, especially in exposed zones (Fig. 9.). In the 1990s and 2000s successful applications of lime-based coatings proved that even porous building stones of low weathering resistance can be protected by simple solutions (Ban et al 2018).

Nevertheless, continuous maintenance and repair of damages are the prerequisites of a long-term protection of sensible stone surfaces (Nimmrichter 2007).

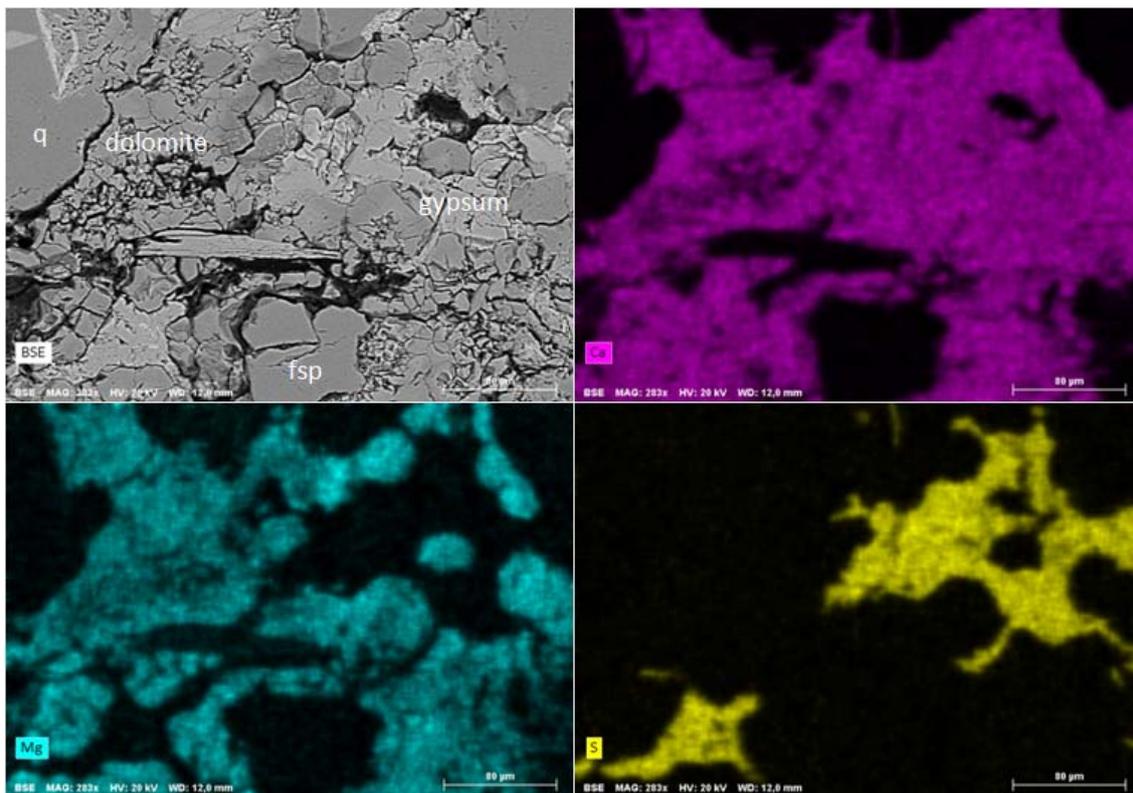
Fig. 10.: SEM-BSD image shows the main mineral components, while EDS mapping proves the correlation between the elements Ca (magenta) and S (yellow) indicating the presence of gypsum in the microcracks. Mg (cyan) only correlates with Ca showing the presence of dolomite cement in the stone (sample SG)

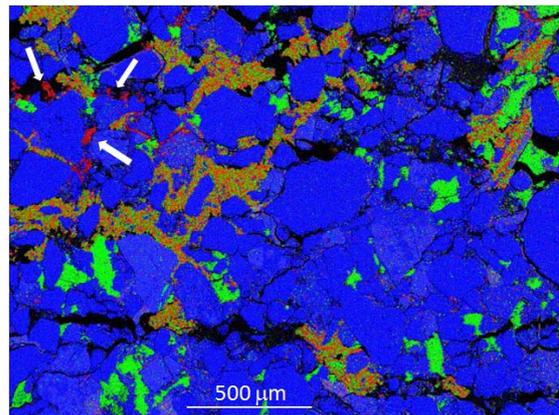
Fig. 11.: SEM-EDS element mapping of sample KB (Kilb, Upper Austria). Between the silicate mineral grains (Si: blue), calcite cement (Ca: green) and gypsum (green [Ca] and red [S]) are visible. Red areas (arrows) suggest the presence of sulphate phases free of Ca (i.e. alkali sulphates).

Similarly to the previous examples, this sandstone exhibits the common degradation pattern; microcracks run sub-parallel to the outer surface, their way of propagation mostly follows the silica grain boundaries and coarse calcite cement also clearly distinguishable from the detrital grains (Fig. 11.). SEM-EDS spot analyses and element mapping indicated the presence of sulphate salts (Fig. 11.), where besides gypsum alkali sulphates were also detected (Fig. 11.). Furthermore, the distribution pattern of sulphates is different from that of the samples TU and SG. In the sample KB the microcracks are not completely filled with the newly formed sulphate products, but rather form isolated clusters (Fig. 11.). This distribution pattern is similar to that of the calcite cement, indicating the direct formation of gypsum from calcite with subsequent degradation of the stone. The large amount of alkalis, also proved by IC (Pintér 2013),

suggests the impact of Portland cement-based materials. Due to static considerations the spire was reinforced with a concrete ring beam in the mid-20th century, being in direct contact with the sandstone ashlars. The massive concrete structure affected the weathering of the stone in two different ways. First, the movement of moisture in the masonry is blocked and redirected by the less porous concrete, leading to an increased water load in the building stone. Secondly, water mobilizes and transports soluble components (i.e. alkalis, sulphates) from the cementitious construction material. Consequently, mineral solutions penetrate the stone substrate where dissolved sulphate and alkali ions react with the calcite of the sandstone, as well as directly crystallize from the solution. Subsequent crystallization pressure causes flaking and granular disintegration, followed by a massive material loss on the surface. Although the sample originates from the inner side of the belfry, damaged openings allowed for moisture (i.e. rain and snow) to directly enter the tower. Additionally, low temperatures in the winter months may have contributed to damages due to freeze-thaw cycles.

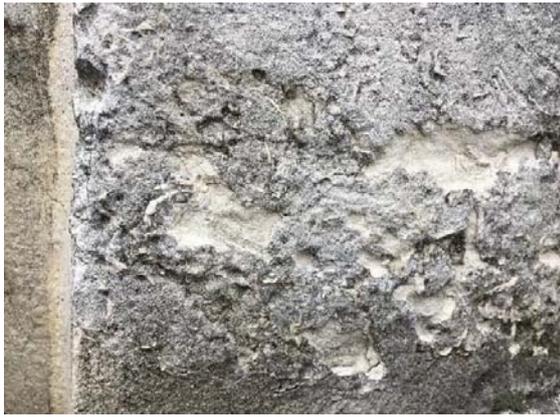
Fig. 13.: Weathering of porous biocalcarenite at the Spinnerin am Kreuz, Wiener Neustadt, Lower Austria (sample WN; picture: Pliessnig & Mozdyniewicz 2019).

The damaged stone surface of the 19th century renovation was first treated in the 1990s with ethyl silicate consolidants. After approx. 20 years of service life scaling of the already treated surface was observed (Fig. 13.). Although the influence of damaging salts has been excluded by laboratory analysis (Pintér 2019b), detailed microscopic analysis revealed a very heterogenous distribution of the consolidant (Fig. 14a). While in the sub-surface areas (up to a depth of 1 to 1.5 mm) large amount of precipitated silica gel was detected, deeper zones contained the consolidant only sporadically (Fig. 14a). Surprisingly, and also very atypically for ethyl silicate consolidants, many pores were completely filled with silica gel (Fig. 14b). Furthermore, microcracks in a depth of 2 to 2.5 mm indicated a weak zone between the outer and inner parts of the stone. The above described phenomenon is a clear evidence for the over-consolidation of a surface; a common problem in case of not properly executed treatments.

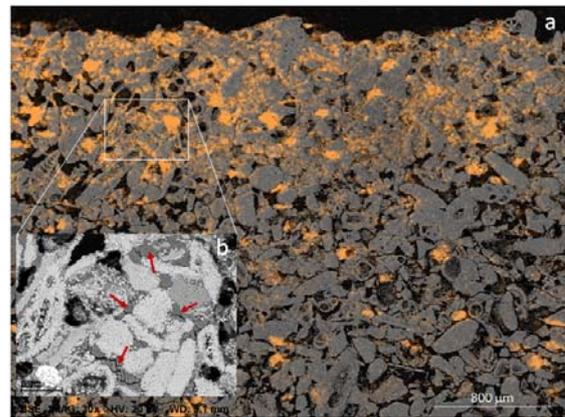
Fig. 14.: SEM-BSD image and element mapping of sample WN. Ochre areas (a) show the distribution of Si (i.e. mostly silica gel and some quartz). Si enrichment in the subsurface zones indicates the enrichment of silica gel as an evidence of over-consolidation of the surface (b, arrows)

It happens when the consolidant migrates back towards the surface as a consequence of too fast evaporation resulting from inadequate curing. The fluid ethyl silicate concentrates in the sub-surface zone and after the evaporation of ethanol the solid silica gel remains back in large quantities in the pores below the surface. In this case, atypically for an ethyl silicate consolidation, many pores also became completely filled with the gel provoking not just an over-consolidated outer zone, but also a barrier for moisture migration. Degradation happens, when the moisture enters the stone from the back and cannot leave through the surface. Finally, water retention can cause frost damage in winter, which also happened in the case of the stone column “Spinnerin am Kreuz”.

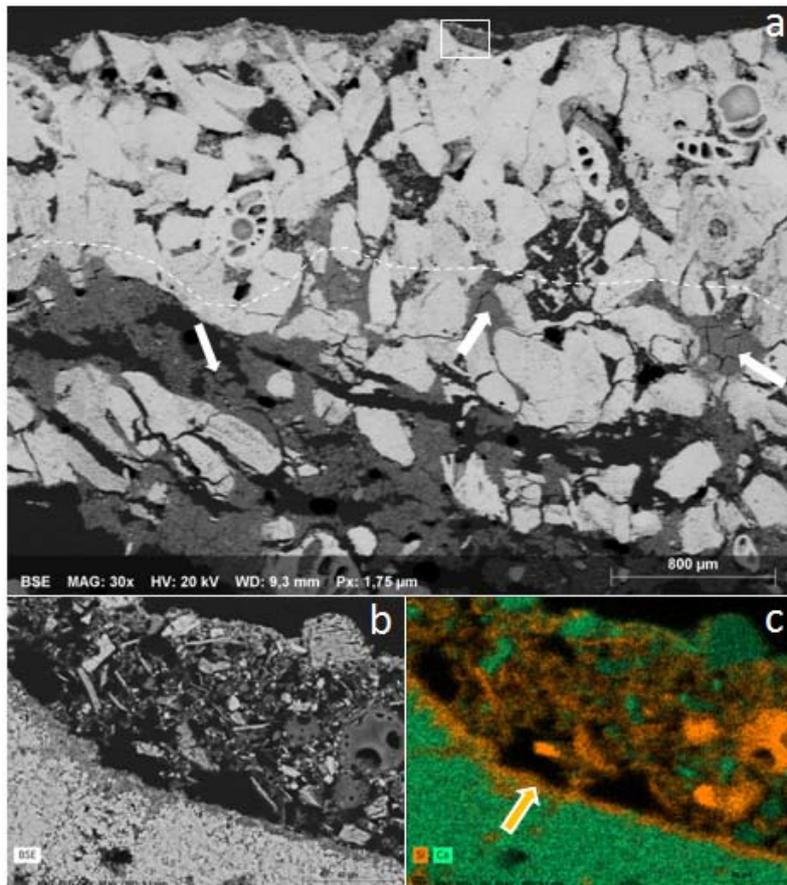
Fig. 15.:
SEM-BSD image and element mapping of sample NK. Arrows show crack- and pore-filling secondary salt and dust deposits, the dotted line indicates the approx. depth of penetration of the water repellent agent (a). The surface is coated with a silicon resin-based slurry (b). Element mapping (Ca [calcite]: green, Si: orange) indicates the presence of a thin water-repellent layer on the top of the substrate (c, arrow)

In situ observations indicated the formation of thin flakes on the surface suggesting a hard and impermeable outer zone. The back side of the detached stone is marked by a massive crack system filled with a mixture of damaging salts and fine dust washed into and deposited in the crack (**Fig. 15a**). The dominance of calcium, alkalis and sulphur in the EDS spectra (Linke 2016) suggests the presence of gypsum and alkali sulphates as secondary products. Additionally, the surface is covered with a 50 to 100 μm thick coating (i.e. protecting layer), where high amounts of lightweight silica filler and a binder rich in Si indicates the use of silicon resin-based slurry (Linke 2016). The pores between the surface and the crack system are almost completely free of any secondary products, suggesting that a barrier for moisture and salt solutions exists several millimetres below the surface. Careful element mapping (**Fig. 15a**) showed the presence of finely distributed Si in the microporosity up to a depth of 2 mm. Also, between the stone and the coating a 5 to 10 μm thin silicon-rich layer was detected (**Fig. 15b-c**). Enrichment of Si in the porosity refers either to the use of ethyl silicate consolidant (see samples TU and WN), or the use of a silan/siloxane-based water-repellent agent, or the combination of both.

Since characteristic silica gel deposits could not be observed, the detected Si enrichments were interpreted as a tracer of a hydrophobic treatment.

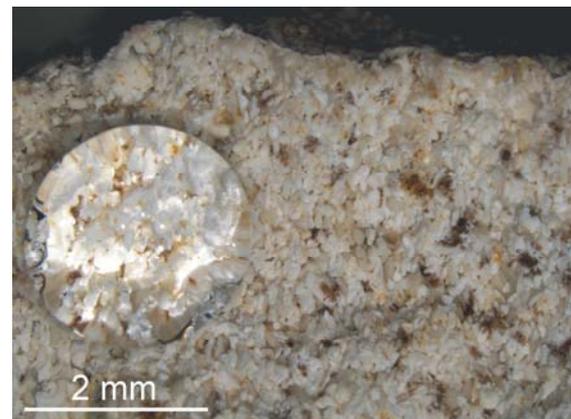
Fig. 16.: Water droplet test performed on the broken surface of sample NK. Due to large contact angles (i.e. hydrophobic treatment) the water droplet cannot penetrate the pores (stereo microscopy)

To control this assumption, a simple water droplet test was performed on the fresh broken surface of the sample. The water droplet on the broken surface (**Fig. 16.**) caused by a large (i.e. $>90^\circ$) contact angle, proved the hydrophobic property of the stone up to a depth of 3 mm. The basic idea behind a hydrophobic treatment is to protect a porous mineral material from infiltrating moisture. Normally, a hydrophobic system works properly if there is no other way for the water to penetrate the stone than the outer (treated) surface. Nevertheless, moisture may enter the objects from different directions and sources (Ban et al. 2018). Additionally, a water repellent treatment works in both directions, thus it does not only prohibit the infiltration of e.g. meteoric water, but also act as a barrier for outward moisture movement. The

outwards migrating water, containing in most cases dissolved salts, stays behind the hydrophobic horizon and the evaporation takes place at the hydrophobic barrier below the surface. Subsequent crystallization of mineral components forms damaging salts and crystallization pressure causes delamination or flaking of the substrate. Additionally, the increased accumulation of moisture favours freeze-thaw damages in winter (Nimmrichter 2007, Nimmrichter & Linke 2008). The consequences of the inadequate use of hydrophobic treatment on porous building stones are well-known phenomena (Nimmrichter 2007, Ban et al. 2018) and represent one of the most intensely researched topics among restorers and conservation scientists.
