A LANDSCAPE HISTORICAL OVERVIEW OF THE TWO TÖRÖK-HALOM KURGANS IN KÉTEGYHÁZA, HUNGARY*

BEDE, Ádám^{1*}; CZUKOR, Péter^{2,3}; CSATHÓ, András István⁴; SÜMEGI, Pál^{1,5}

* How to cite this paper: BEDE, Á., CZUKOR, P., CSATHÓ, A.I. & SÜMEGI, P., (2019): A landscape historical overview of the two Török-halom kurgans in Kétegyháza, Hungary, *Archeometriai Műhely* XVI/3 175–188.

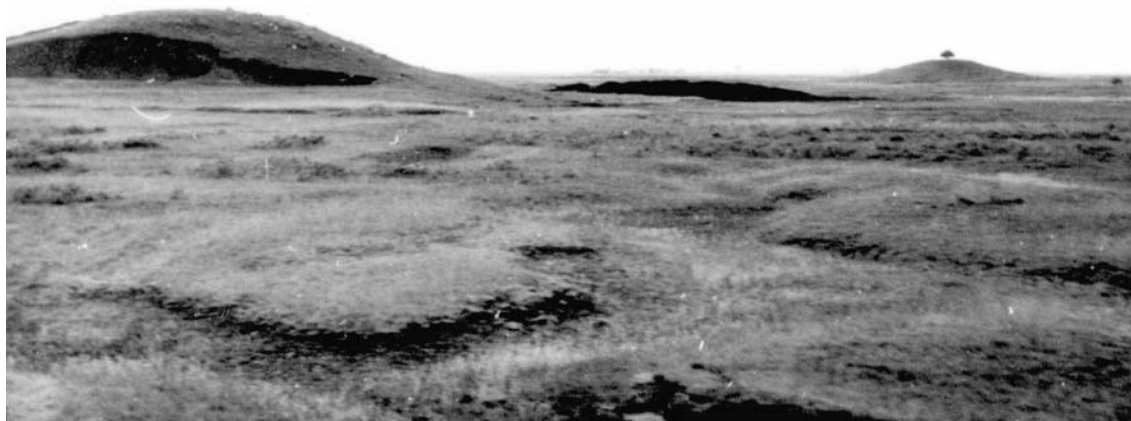
Fig. 2.: The two Török-halom kurgans on the saline grassland in Kétegyháza, 1967 (photo by Gy. Gazdapusztai; MNM RégAd XVIII. 282/1967; Ecsedy 1979, 72, Pl. 4.1)

In addition to the highest mounds – the two Török-halom (**Fig. 2.**) and the Hegyes-halom – a number of medium-sized or lower kurgans were also raised in the area. On both the western and eastern side of the Szabadkígyós-Kétegyháza railway there are two groups of very small barrows. They could remain relatively intact because due to the poor quality of the saline soil, they were probably never ploughed, or they had only a very small amount of disturbance. The 18th-19th-century military, manor and cadastral maps indicate several mounds of the kurgan field, and regularly mark the mounds at border points (M. 1–8). This landscape has been intensively cultivated since the first half of the 18th century, following re-settlement after the Turkish

In the 1960s and 1970s, a tree was standing on the top of the mound (Fig. 2-3.; Dövényi et al. 1977, 9. kép; M.13–14). Apart from this, it was probably always covered by dry grassland, with a loess meadow steppe character, although due to the use and intensive exploitation of the area, both the vegetation and the shape of the mound could have

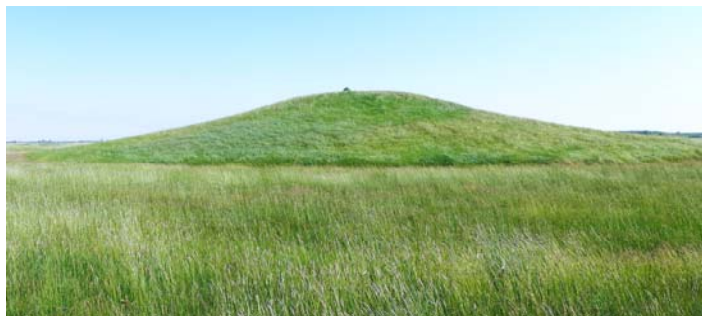
Fig. 4.: The northern Török-halom kurgan in 2017 (photo by Á. Bede)

Even today, it is a huge, imposing mound of regular shape, impressive size and fundamentally intact structure, dominating the landscape in the plain grassland (Fig. 4.). This is the largest of the mounds preserved in their original state, and still in good condition today (Fig. 5.). All around it, the traces of a deeper area can be followed, from which the material of the mound was extracted in the Late Copper Age (these areas are now partly filled, typically marshy, swamp habitats) (Fig. 6-7.).

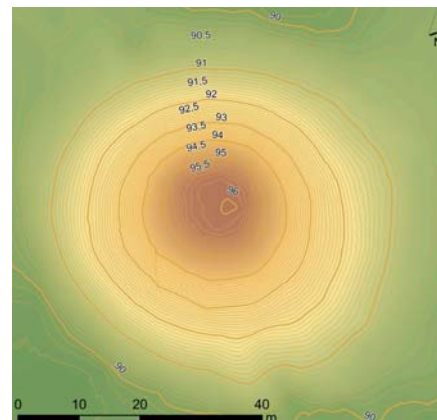
Fig. 5.: Contour surveying map of the northern Török-halom kurgan

The main morphometric data of the northern Török-halom left in its original state are as follows. Central coordinates: WGS84 46°33'01.44" (46.550407) N, 21°08'31.44" (21.142058) E (Google Earth), EOV 810,618, 136,155 (EOTR 38-424; M.14); relative height: 5 m; absolute (altitude) height: 96.1 m; diameters: 58 m and 52 m. Perimeter: 218 m. Floor area: 3,670 m².

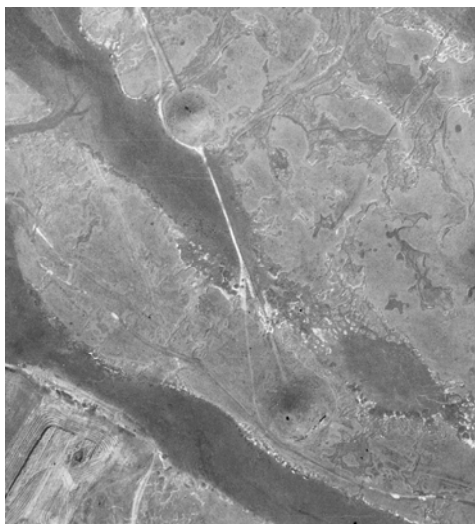
Fig. 6.: An aerial photo of the two Török-halom kurgans in 1962, between the mounds with Medieval border ditch (Fentről.hu)

After the excavation and destruction – and even today – the Late Medieval boundary ditch between the two mounds (Fig. 6.), which separated the administrative areas of Kétegyháza village and Kakucs territory (“puszta”) until 1947 (Németh 2002, 81), is easily discernible. However, just to the south of the mound the line of the ditch becomes uncertain.

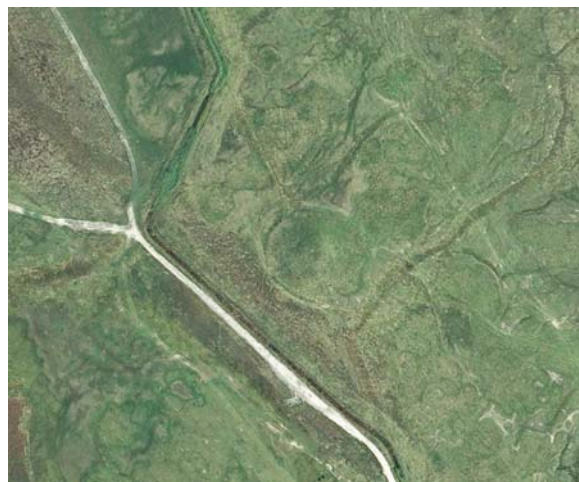
Fig. 7.: An orthophoto of the northern Török-halom kurgan in 2011 (FÖMI)

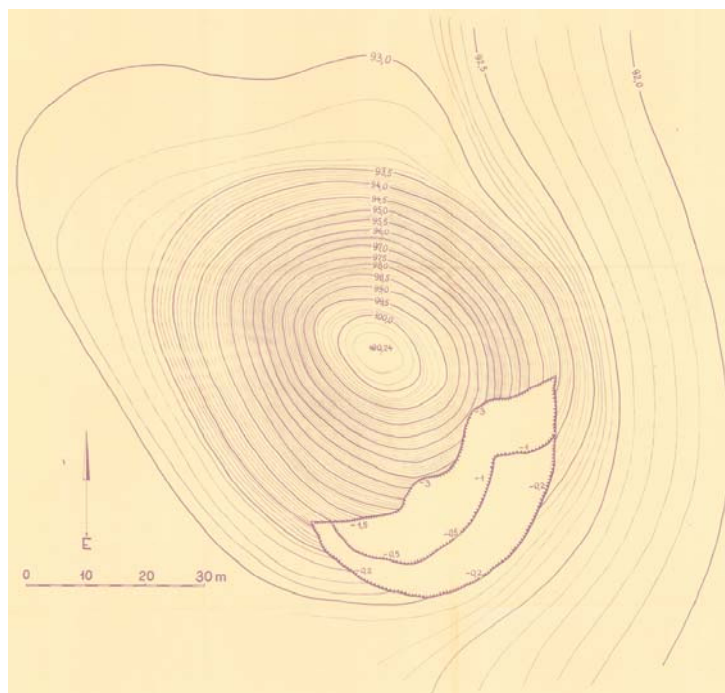
Fig. 8.: Original contour surveying map of the southern Török-halom kurgan in 1966 (MNM RégAd XVIII. 282/1967)

The main morphometric data of the southern Török-halom kurgan before its destruction. Central coordinates: WGS84 46°32'51.32" (46.547241) N, 21°8'35.74" (21.143524) E (Google Earth), EOY 810,731, 135,839 (EOTR 38-442; M.14); relative height: 6.7 m. Absolute (altitude) height: 98.5 m (M.11–12), 97.8 m (M.13). Diameters: 74 m and 64 m. Perimeter: 220 m. Floor area: 3,770 m. Toponym on map: Török-hlm. (M.14).

A useful contour-map of its original shape was made in 1966 by Gyula Gazdapusztai and József Tóth (Fig. 8.; Gazdapusztai & Tóth 1966; MNM RégAd XVIII. 282/1967; Ecsedy 1979, 21, Fig. 8). In the course of the excavation in 1967, the centre of the kurgan was completely cut through, and its cross-section and the thickness of its layers were published by István Ecsedy (Fig. 9.; Ecsedy 1979, 24, Fig. 13–14).

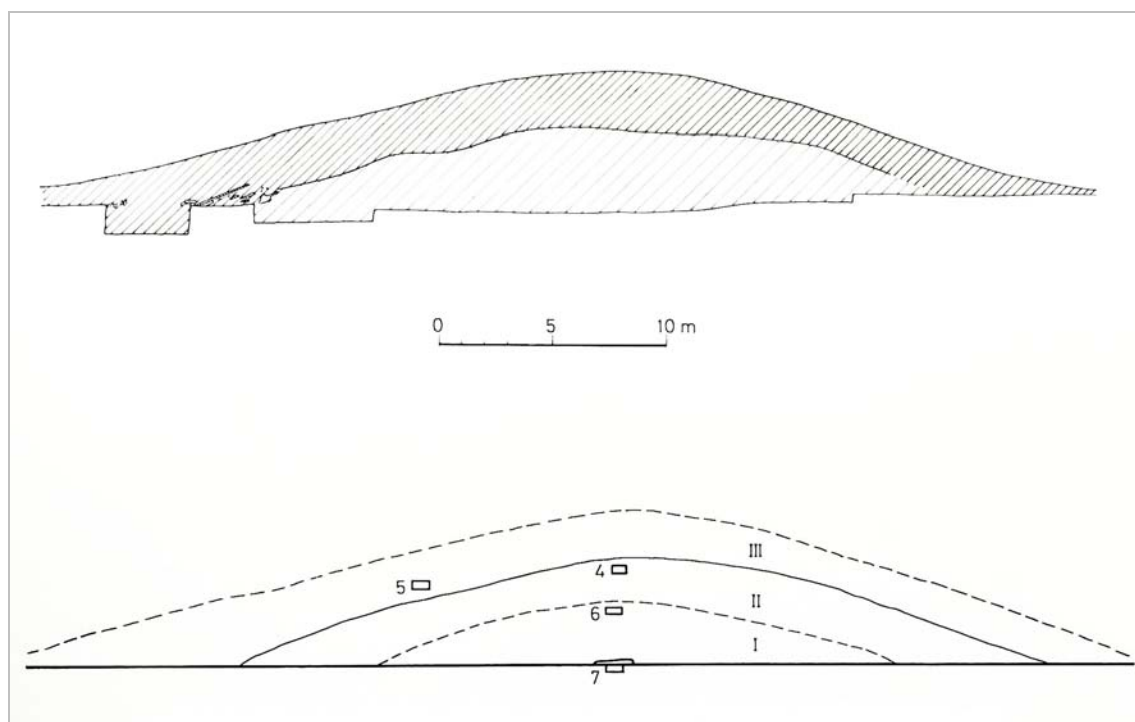
Fig. 9.: The cross-sectional profile interpretation of the excavated southern Török-halom kurgan (Ecsedy 1979, 24, Fig. 13–14)

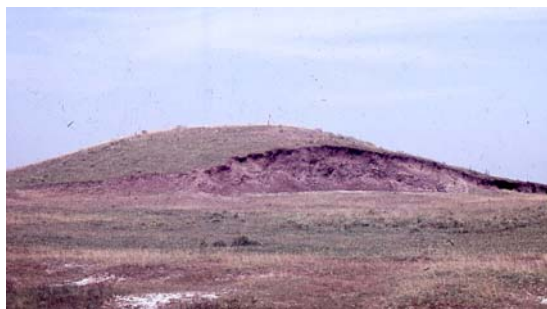
Fig. 10.: The injured southern Török-halom kurgan before the archaeological excavation in 1967 (photo by I. Ecsedy; MTA RégInt, Photographs 10.231)

The (rescue) excavation took place because the cooperative of Kétegyháza began to carry away the material of the kurgan to fill up the streets of the village; its south-eastern side had already been disturbed (Fig. 8., 10.). An aerial photo taken in 1962 already shows the destruction (Fentről.hu), but in 1953 it was not yet visible (Military History Map Collection, L-34-55-A-d). In the course of the excavation, the high-performance machines took out hundreds of cubic meters of earth from the central part of the kurgan within a few weeks, cutting a thick strip into its centre (Fig. 3.). For years after the documented archaeological work, the locals had been carrying away the earth from the mound (Fig. 11.), until it disappeared almost completely. In the spring of 2011, there was still a 1.2-meter-high “in situ” piece on its western periphery, with dugouts and smaller piles of earth in the central part of the mound (Fig. 12.). Despite its almost complete destruction, the outline of its location was still visible, with only a few *Elaeagnus angustifolia* trees standing on it.

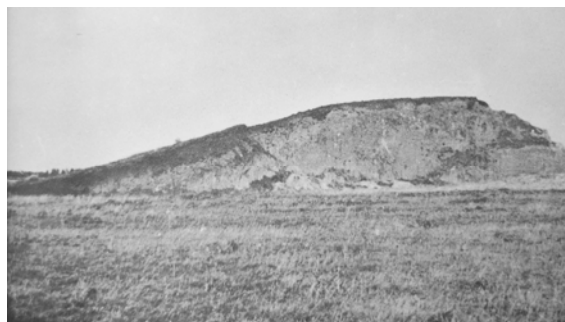
Fig. 11.: The damaged southern Török-halom kurgan in the 1970s (Dövényi et al. 1977, Fig. 7)

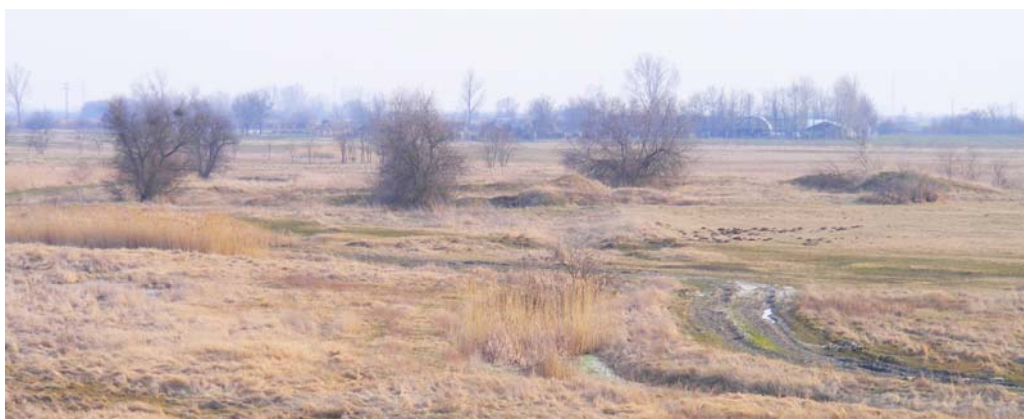
Fig. 12.: The site of the destroyed southern Török-halom kurgan with original bottom parts on the right side of the picture (photo by Á. Bede, 2011)

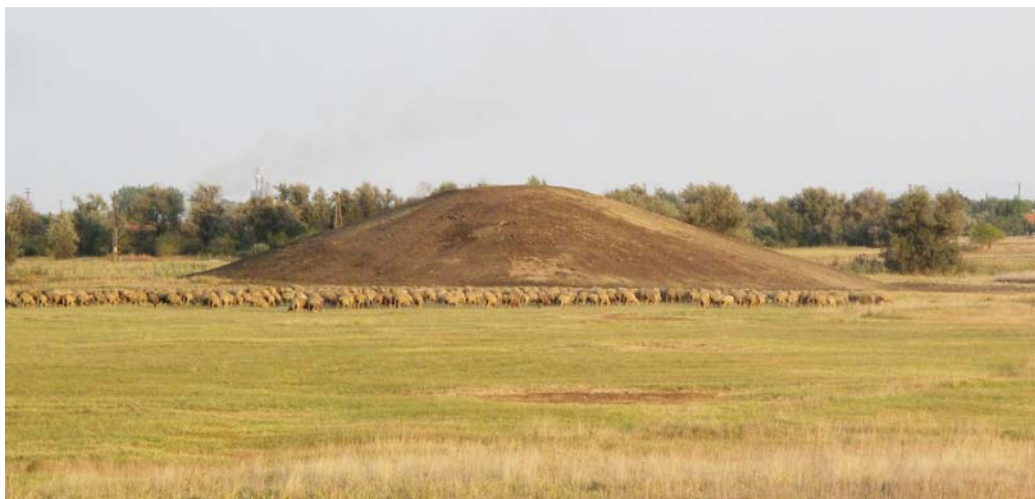
Fig. 13.: The rebuilt southern Török-halom kurgan in 2011, Autumn (photo by B. Forgách)

The rebuilding of the southern kurgan was part of the regional habitat conservation and restoration concept of the Körös-Maros National Park Directorate, and was completed in July-August 2011 after a long planning phase (Fig. 13.; Nagy 2012, 99–100). To this end, the shape and morphological character of the northern Török-halom were used, adapted to the dimensions of the former mound. Although the survey of the original mound from 1966 was available (Gazdapusztai & Tóth 1966; MNM RégAd XVIII. 282/1967; Ecsedy 1979, 21, Fig. 8), this source was unfortunately not known by the designers and was not taken into account. Unfortunately, during the construction, the “in situ” periphery was covered with earth in a large area, thus not only the last remains of the original point were destroyed, but a part of the residual loess vegetation was also lost.
