## ANALYSES OF MORTARS FROM ST. GEORGE'S CATHEDRAL, GREAT NOVGOROD

### A VELIKIJ NOVGORODI SZT. GYÖRGY-KATEDRÁLIS HABARCSAINAK VIZSGÁLATA •

• How to cite this paper: IANOVSKAIA, E.G., VOZNIAC, A.A., NOSOVA, A.A., SAZONOVA, L.V., LEBEDEVA, N.M. & EROFEEVA, K.G. (2025): Analyses of mortars from St. George's cathedral, Great Novgorod / A velikij novgorodi Szt. György-katedrális habarcsainak vizsgálata, *Archeometriai Műhely* XXII/1 39–54.

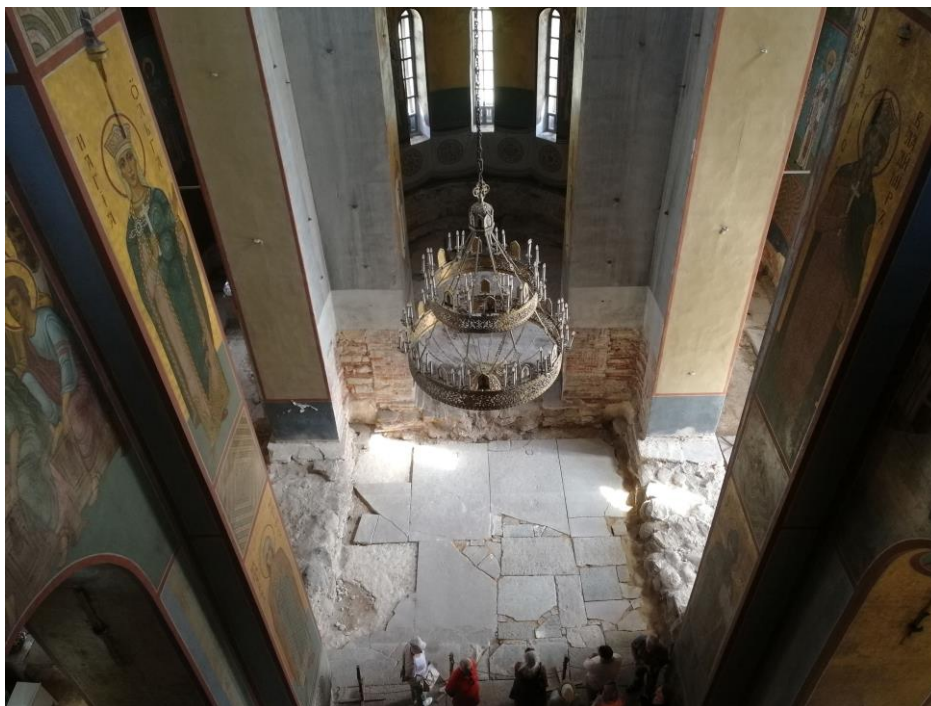
**Fig. 2.:**  
St. George  
Cathedral.  
Eastern part.  
Excavated  
constructions.  
View from  
Western gallery

The nowadays exterior of the Cathedral is a result of the restoration in the 1930s (**Fig. 1**). During the archaeological excavations of 2013–2021 inside the Cathedral, the 12<sup>th</sup> century floor made of limestone slabs, the Cintron with the Bishop's throne, three altars (in three apses), the underground tomb in the Narthex etc. were brought to light. In addition, more than 400 thousand fragments of fresco paintings, that had been knocked down and used as filler under the iron floor during the global reconstruction in 1825–1827, were found (Sedov et al. 2016). Now, almost all these constructions are open and visible, waiting for restoration (**Fig. 2**).

The binder of all samples is composed of calcite and has micritic structure (**Figs. 4–6**). The binder of some pre-Mongolian mortar samples (S-8, S-13, S-17) contains cracks "healed" by crystallized lime (**Fig. 5b**, **Fig. 6c-d**). This phenomenon could be the result of pozzolanic reaction in the binder appeared as regenerative cementitious resilience that discovered in Roman pozzolanic cements (Jackson et al. 2017). Most cracks were detected in the floor mortar (S-8) which was under pressure of stone floor slabs (**Fig. 2**).

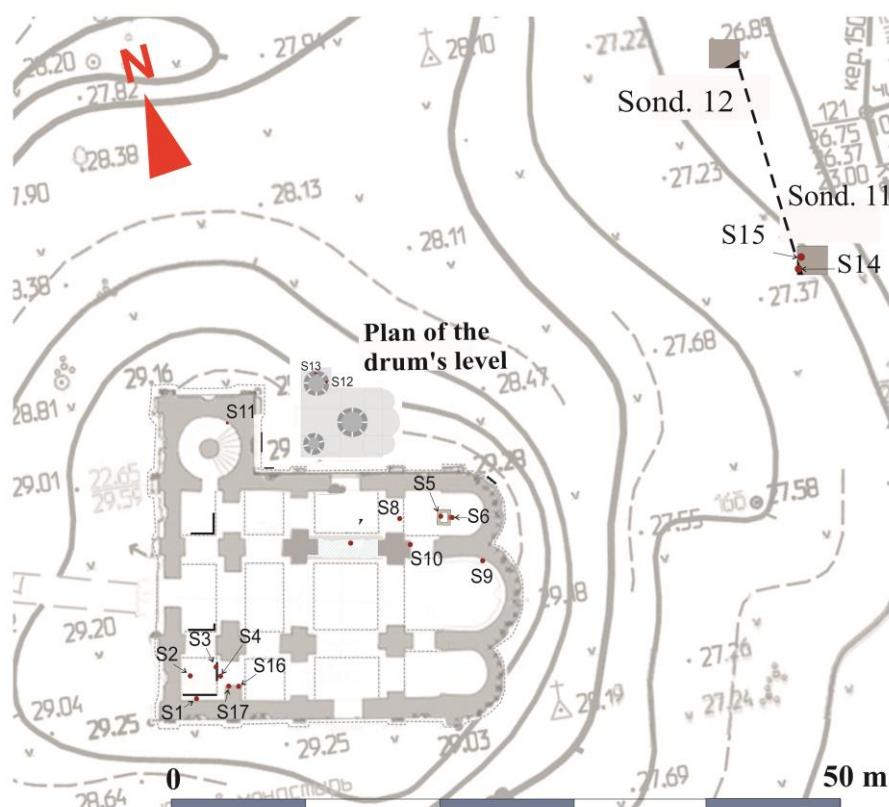
**Fig. 3.:**  
St. George  
Cathedral of the  
Yuriev  
Monastery. Plan  
with the samples

During the 2021 excavation on the territory of the Monastery, 17 mortar specimens were collected from structural walls and foundations, flooring and plastering. Four samples come from different foundation constructions, discovered in the south-western underground tomb (S-1, S-2, S-3, S-4). Two mortar samples were collected from the northern altar, apparently built after the erection of the Cathedral: one from the actual altar (S-5) and one from a later phase on top of it (S-6). Two samples were taken in the northern gallery: one from the strip foundation under the base of the columns of the 19<sup>th</sup> (S-7) and the second from the filling under the floor of the 12<sup>th</sup> century (S-8). Two more samples come from the crimson plaster in the main apse (S-9), and one from the Eastern wall (S-10). One sample was taken from the wall of the Tower between the first and second floor (S-11). Two mortar samples were collected from the walls of the Chapel above the Tower (S-12, S-13) and two more from the South-West semi-pillar (in the narthex) that has an additional part of unknown date (S-16, S-17). Two samples of mortar from constructions with unknown function and date were taken from Sondage 11 (S-14, S-15) (**Fig. 3**).

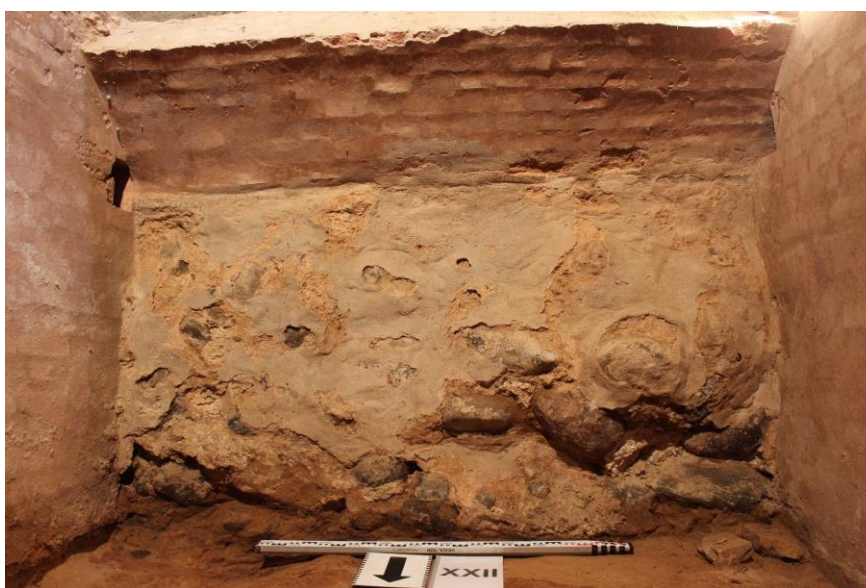
**Fig. 7.:**  
South-West Tomb.  
Foundation. South  
wall. View from the  
North

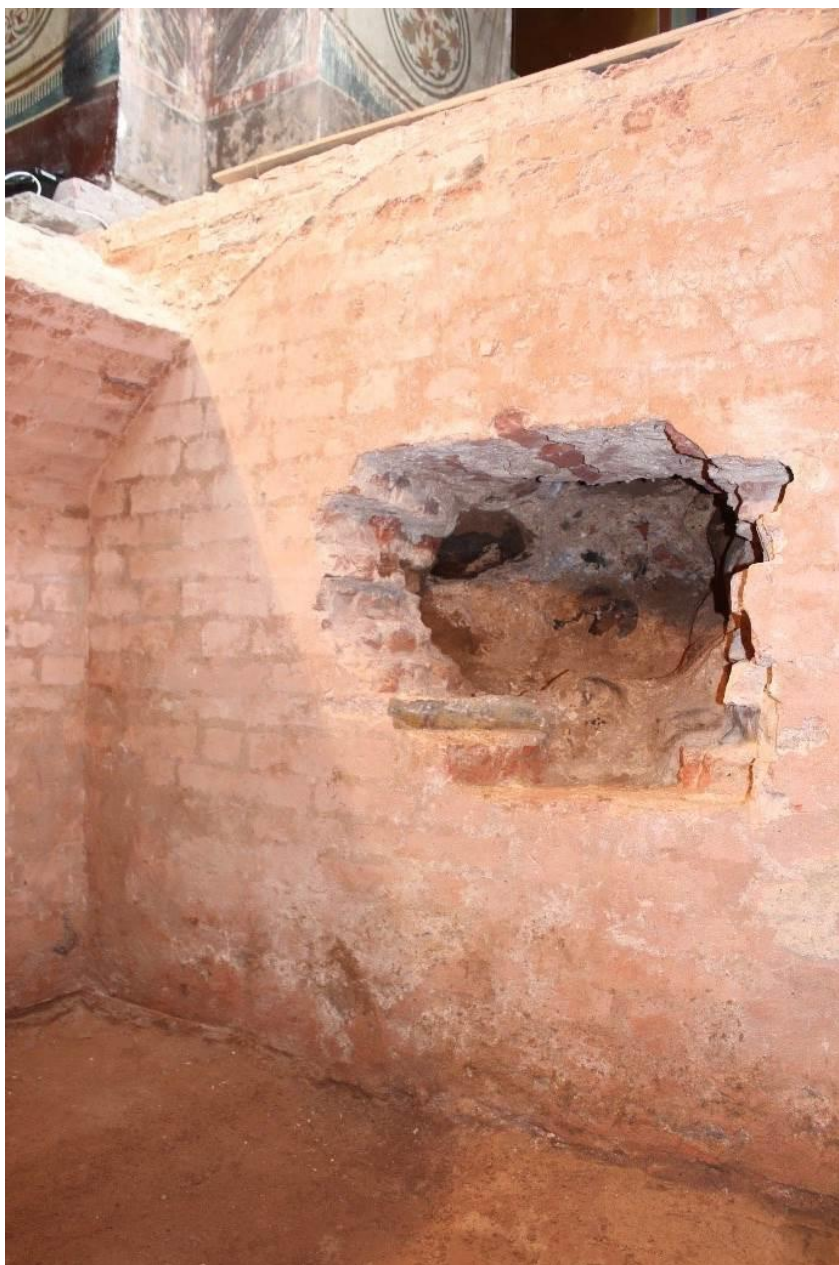
**Fig. 8.:**  
South-West Tomb.  
Strip foundation  
between semi-pillar  
and column, 12th  
century. View from  
the South-West

Samples S-2 and S-4 from the 12<sup>th</sup> century foundation (**Fig. 8**) are similar, with a large amount of brick fragments (0.3 to 5 cm in length) and a very small amount (around 5%) of sand, mainly consisting of monomineralic quartz. Organic material (possibly wood) is present in both samples. It is important to note that lime lumps which could be the fragments of earlier mortars (with angular shape) are also present in these samples.

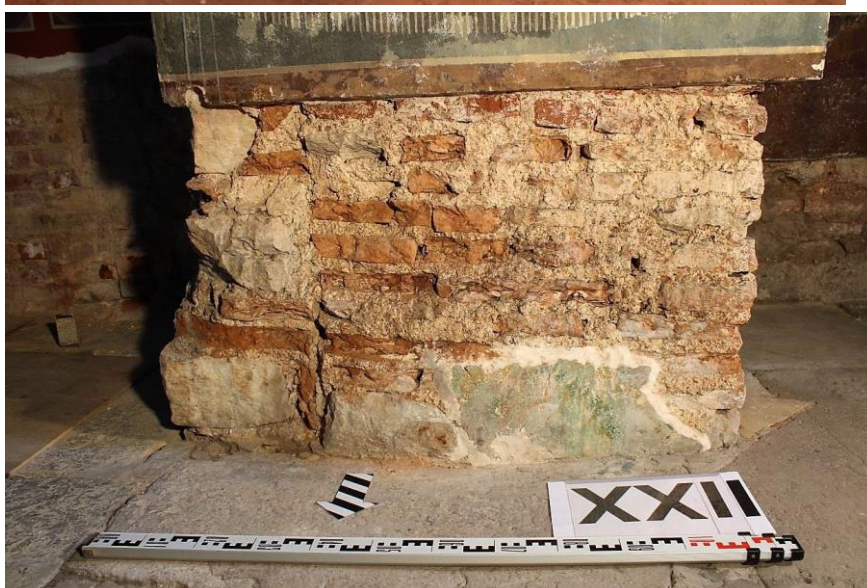
**Fig. 9.:**  
South-West semi-  
pillar. Vertical seam in  
the center of the pillar.  
View from the North

The samples from the wall, S-12 and S-13, were taken from the holes left by the now missing beams in the Tower Chapel. S-12 was very friable and had to be prepared in an epoxy mount. Both mortars contain fragments of ad hoc baked clay. This kind of additive was not found in the mortars of the foundation. However, it could be seen in sample S-17 of wall mortar from the south-western semi-pillar (**Fig. 9**) which contains two kinds of masonry. Both of them consist of the so-called plinfa (thin Byzantine brick) which was used in Novgorod only in pre-Mongolian period. The two types of masonry are divided by a vertical seam in the center of the pillar. The mortar on the East of the pillar contains a binder similar to that of the foundation mortars (S-2, S-4 with a more grayish color and the brick fragments show the same angular shape). The mortar on the West of the pillar is similar to the mortar from the Tower Chapel. We suggest, therefore, that some changes in the structure of the Cathedral were carried out already in the first construction period and that the western part of the pillar was rebuilt at the construction time of the Tower Chapel.
