THE EFFECT OF ANTHROPOGENIC ACTIONS ON THE WEATHERING OF POROUS BUILDING STONES – EXAMPLES FROM THE AUSTRIAN CONSERVATION PRACTICE*

Farkas PINTÉR¹

¹ Scientific Laboratory, Federal Monuments Authority Austria, Arsenal 15/4, A-1030 Vienna, Austria

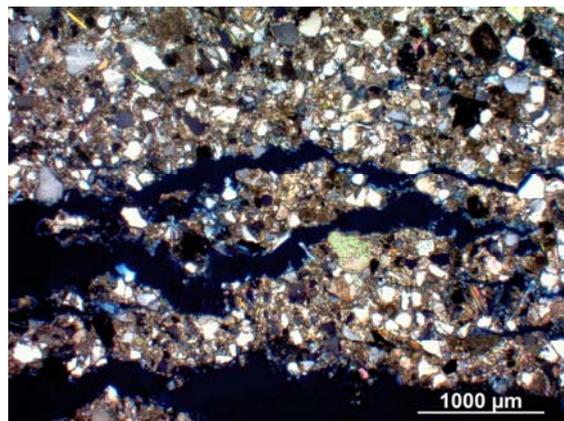
Fig. 3.: Characteristic textural appearance of molasse sandstone (subarkose) with large amount of secondary sparitic dolomite cement (sample SG, Lower Austria, +N).

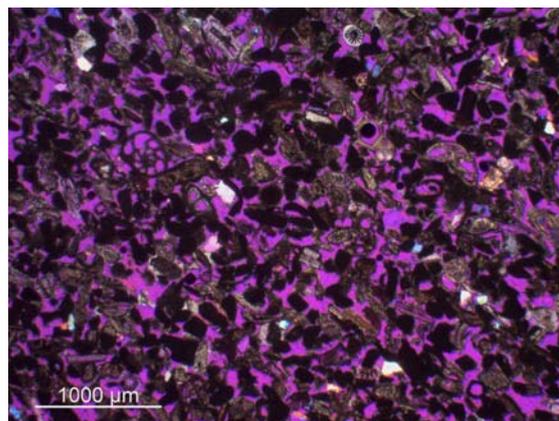
Fig. 12.: Characteristic textural appearance of Tertiary biocalcarenite from the Leitha Mts., Lower Austria/Burgenland. The components are predominantly made up of calcareous algae and foraminifera fragments and a few detrital quartz grains. The high porosity is highlighted by the magenta colour (+N, λ plate)

The zone where the sample was taken from is connected to the 19th century renovation activities. The stone is a porous calcarenite made predominantly up of the fragments of calcareous algae (Figs. 12. and 14.) and foraminifera originating from one of the historical quarries on the northwestern slopes of the Leitha Mts. Although these fine-grained sedimentary rocks were used as significant sculptor stones, their low resistance against weathering has been known for centuries.
